#### DEFECTS IN FLEXIBLE AND RIGID PAVEMENTS

#### **Defects in Flexible Pavements**

#### **Defects in Rigid Pavements**

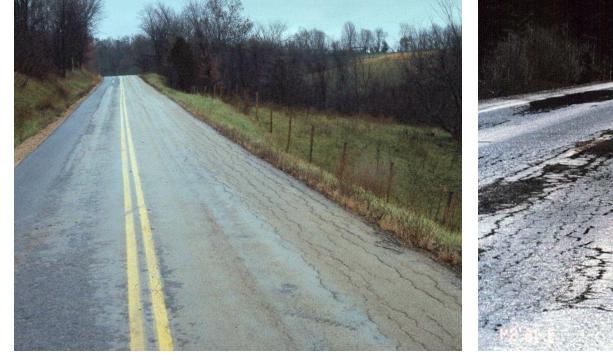
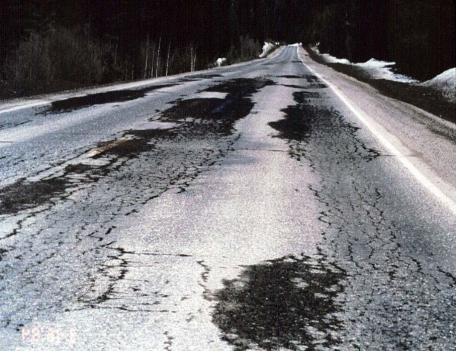
Fatigue cracking from edge failure Fatigue cracking from frost action

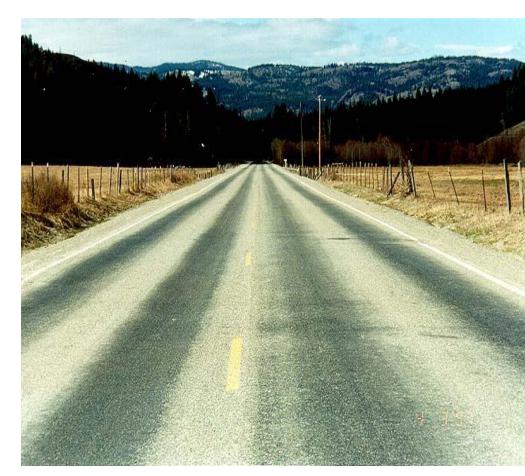
**Description:** A film of asphalt binder on the pavement surface. It usually creates a shiny, glass-like reflecting surface that can become quite sticky.

Bleeding in wheelpaths

2. Excessive application of asphalt binder during BST application (as in the above figures)

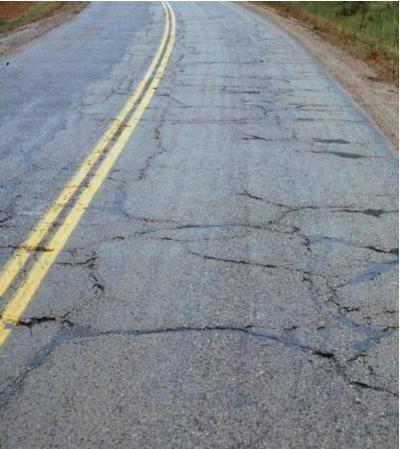
**Description:** Interconnected cracks that divide the pavement up into rectangular pieces. Blocks range in size from approximately 0.1 m<sup>2</sup> (1 ft<sup>2</sup>) to 9 m<sup>2</sup> (100 ft<sup>2</sup>). Larger blocks are generally classified as longitudinal and transverse cracking. Block cracking normally occurs over a large portion of pavement area but sometimes will occur only in non-traffic areas.

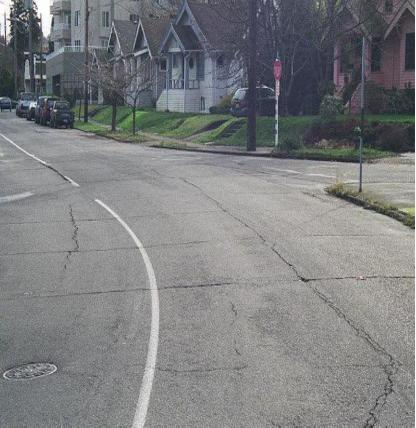
**Description:** Cracks in a flexible overlay of a rigid pavement.

Joint reflection cracking on an arterial

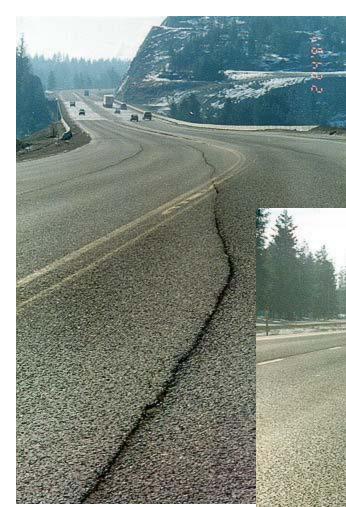
# Longitudinal cracking from poor joint construction

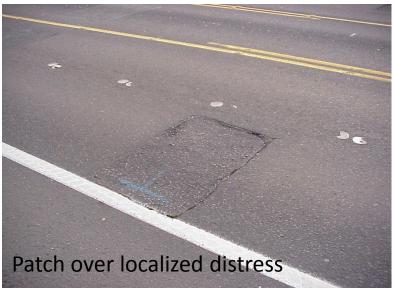
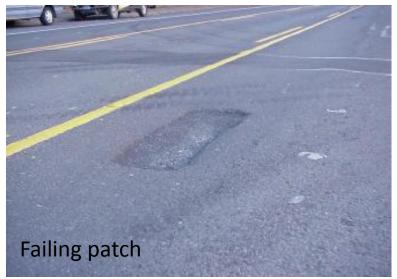
**Description:** An area of pavement that has been replaced with new material to repair the existing pavement. A patch is considered a defect no matter how well it performs.

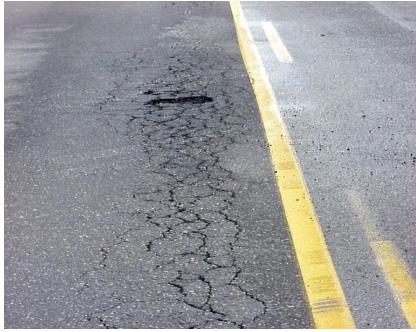
Generally, potholes are the end result of alligator cracking. As alligator cracking becomes severe, the interconnected cracks create small chunks of pavement, which can be dislodged as vehicles drive over them. The remaining hole after the pavement chunk is dislodged is called a p

pavement chunk is dislodged is called a pothole. Developing pothole

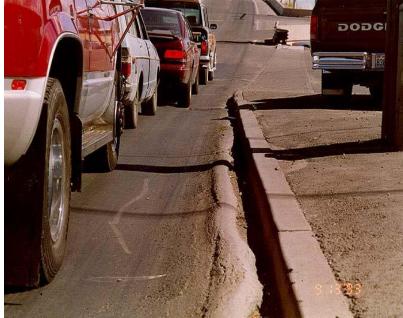
- **Description**: Surface depression in the wheelpath. Pavement uplift (shearing) may occur along the sides of the rut. Ruts are particularly evident after a rain when they are filled with water. There are two basic types of rutting: mix rutting and subgrade rutting. Mix rutting occurs when the subgrade does not rut yet the pavement surface exhibits wheelpath depressions as a result of compaction/mix design problems. Subgrade rutting occurs when the subgrade exhibits wheelpath depressions due to loading. In this case, the pavement settles into the subgrade ruts causing surface depressions in the wheelpath.
- **Problem:** Ruts filled with water can cause vehicle hydroplaning, can be hazardous because ruts tend to pull a vehicle towards the rut path as it is steered across the rut

Permanent deformation in any of a pavement's layers or subgrade usually caused by consolidation or lateral movement of the materials due to traffic loading. Specific causes of rutting can be:

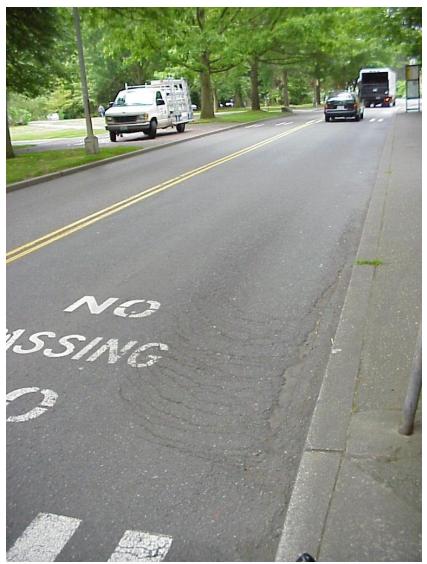
**Description:** Crescent or half-moon shaped cracks generally having two ends pointed into the direction of traffic.

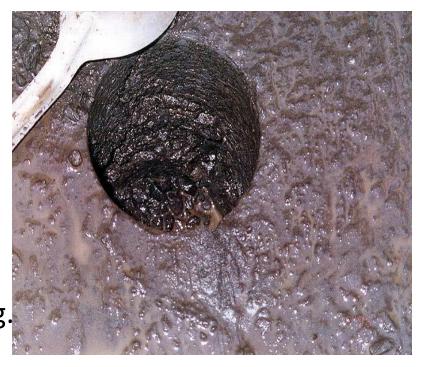
**Description:** The loss of bond between aggregates and asphalt binder that typically begins at the bottom of the HMA layer and progresses upward. When stripping begins at the surface and progresses downward it is usually called raveling. The photo shows the surface effects of underlying stripping.

Core hole showing stripping at the bottom

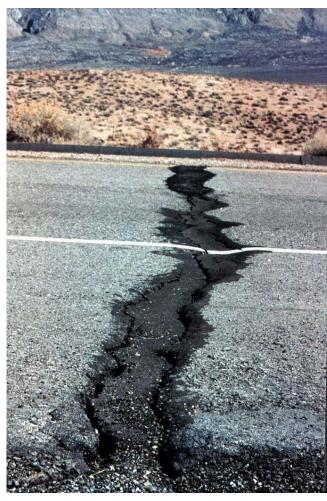
Large patched thermal crack

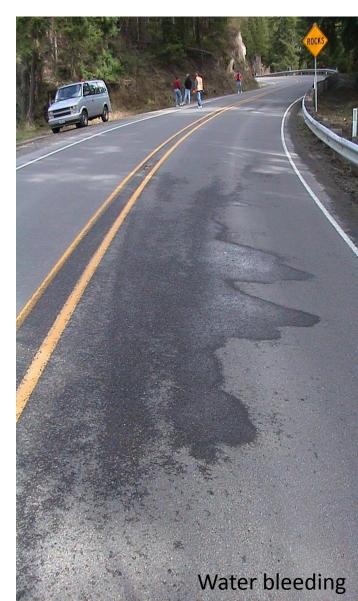
**Description:** Water bleeding occurs when water seeps out of joints or cracks or through an excessively porous HMA layer. Pumping occurs when water and fine material is ejected from underlying layers through cracks in the HMA layer under moving loads.

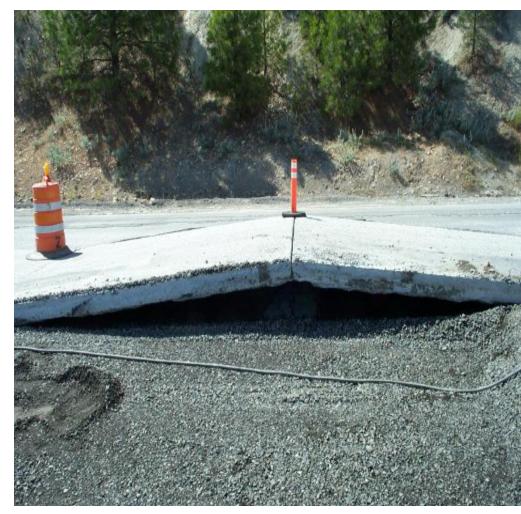
Description: A localized upward slab movement and shattering at a

joint or crack. Usually occurs in spring or summer and is the result of insufficient room for slab expansion during hot

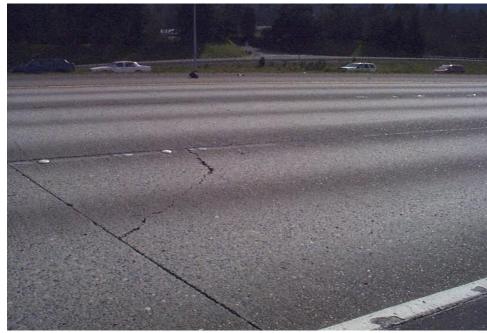
**Description:** A crack that intersects the PCC slab joints near the corner. "Near the corner" is typically defined as within about 2 m (6 ft) or so. A corner break extends through the entire slab and is caused by high corner stresses.

Corner break on a highway

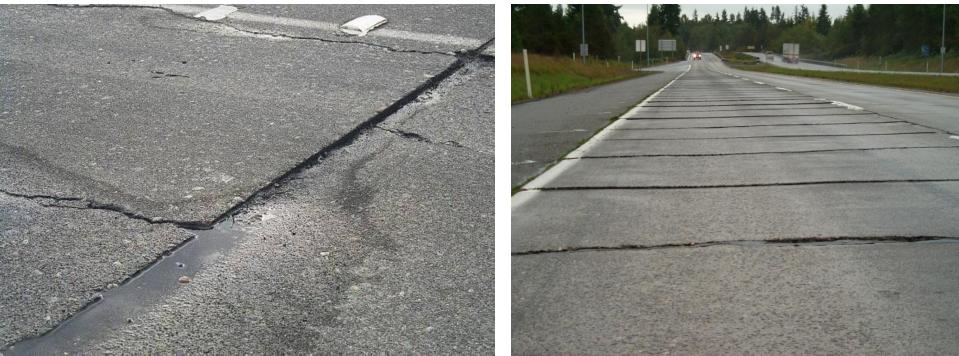
- **Description:** A difference in elevation across a joint or crack usually associated with undoweled JPCP. Usually the approach slab is higher than the leave slab due to pumping, the most common faulting mechanism. Faulting is noticeable when the average faulting in the pavement section reaches about 2.5 mm (0.1 inch). When the average faulting reaches 4 mm (0.15 in), diamond grinding or other rehabilitation measures should be considered.
- **Problem:** Roughness
- **Possible Causes:** Most commonly, faulting is a result of slab pumping. Faulting can also be caused by slab settlement, curling and warping.

Up close near a bus stop

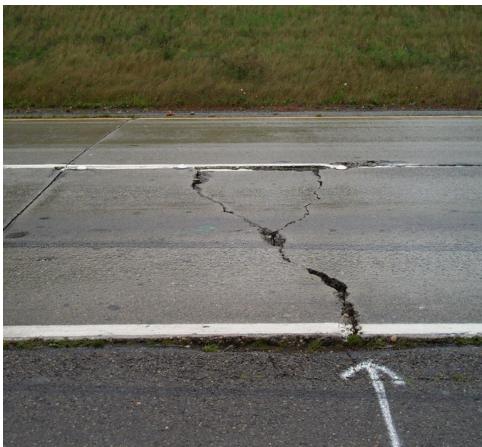
**Description:** Linear cracks not associated with corner breaks or blowups that extend across the entire slab. Typically, these cracks divide an individual slab into two to four pieces.

Large panel crack

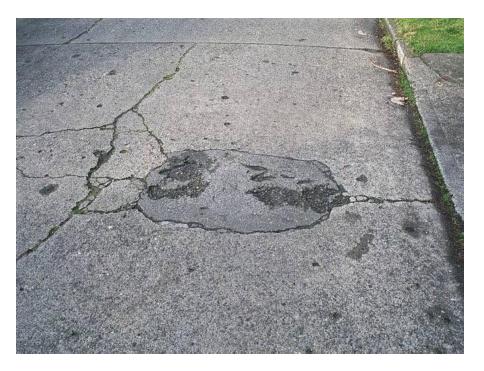
Patch on a residential street

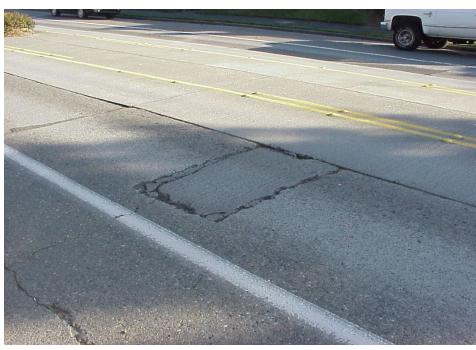
Patch with poor edges

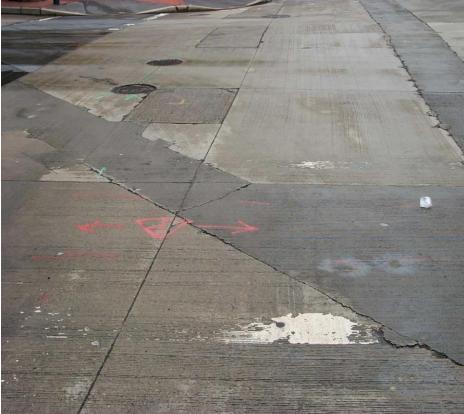
Large utility patch

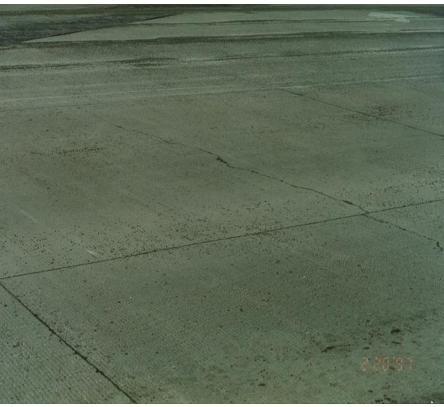
**Description:** Hairline cracks formed during PCC setting and curing that are not located at joints. Usually, these cracks do not extend through the entire depth of the slab. Shrinkage cracks are considered a distress if they occur in an uncontrolled manner.

Shrinkage cracks on brand new slabs

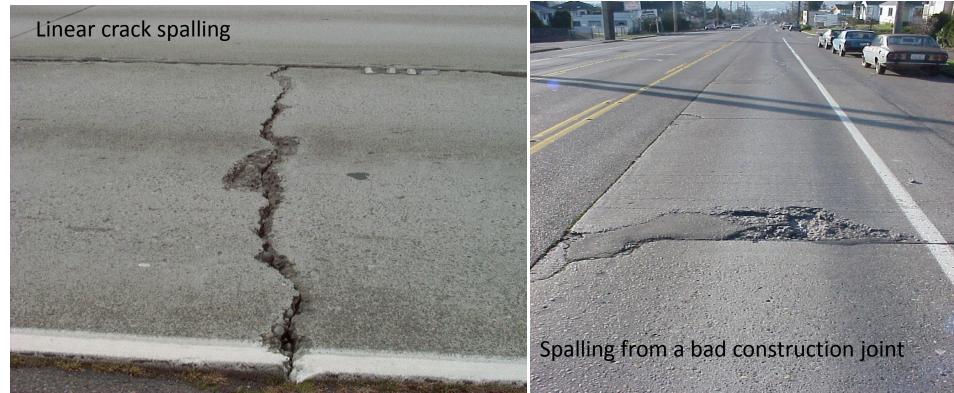
### **Spalling**

- **Description:** Cracking, breaking or chipping of joint/crack edges. Usually occurs within about 0.6 m (2 ft.) of joint/crack edge.
- **Problem:** Loose debris on the pavement, roughness, generally an indicator of advanced joint/crack deterioration
